ALCOTT ERU ENERGY WHEEL REPLACEMENT

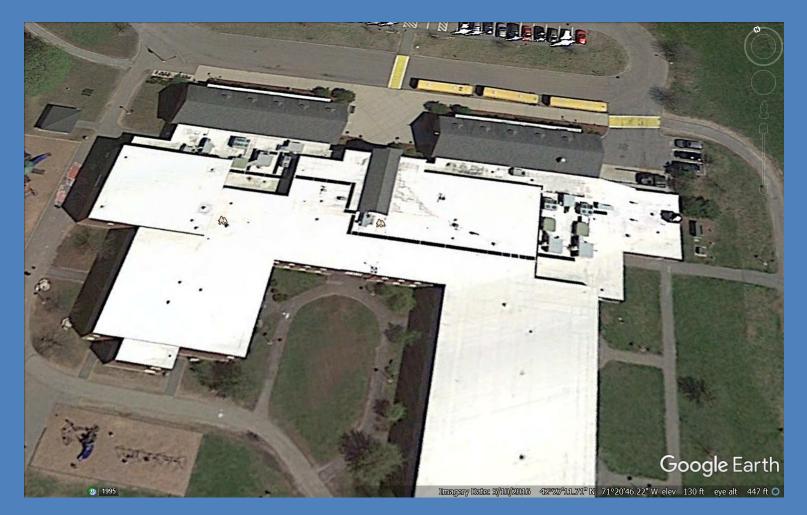
ALCOTT ERU ENERGY WHEEL REPLACEMENT

The ERU'S are currently designed as 100% outdoor air units. If the energy recovery wheel fails the unit cannot maintain the proper discharge air temperatures. The energy wheels will be replaced to ensure proper operation.

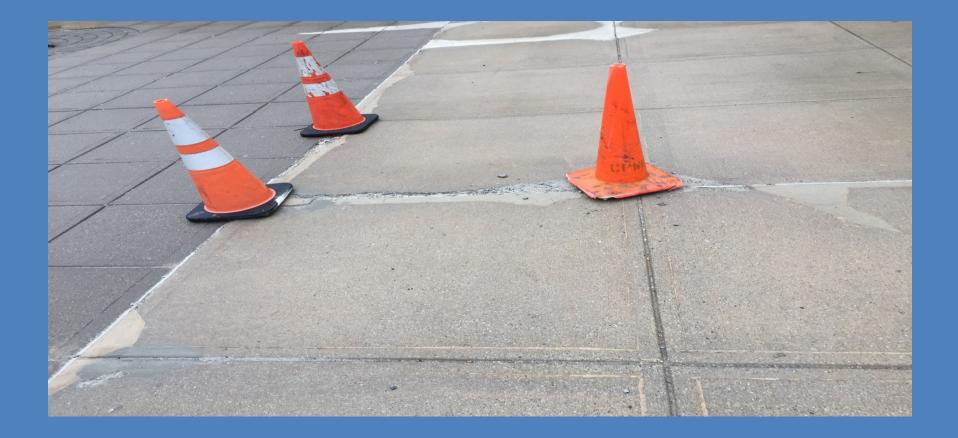
THOREAU SIDEWALK REPAIR / REPLACEMENT Sidewalks are decaying posing a safety hazard

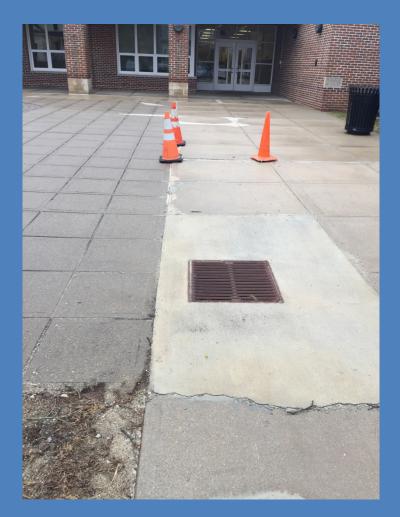
THOREAU SIDEWALK REPAIR/REPLACEMENT Sidewalks are decaying posing a safety hazard

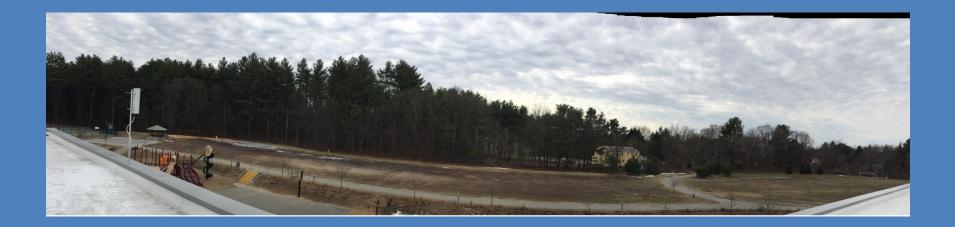
WILLARD FIELD RENOVATIONS Renovate the playground and install irrigation for maintenance purposes.
