DESIGN SUB COMMITTEE
8.31.2021

BUILDING FORM

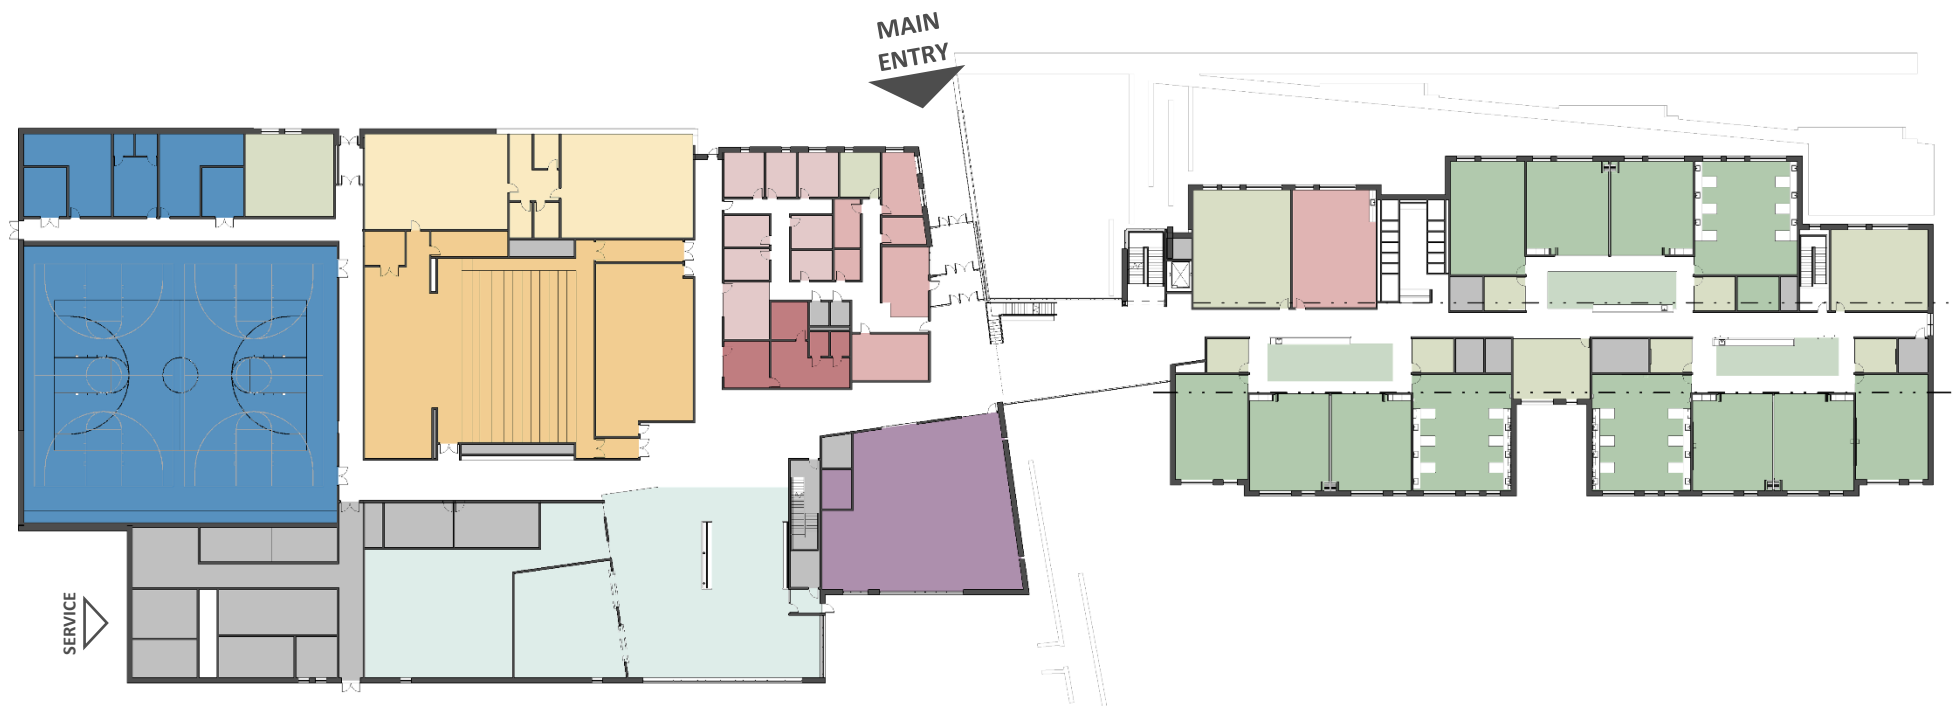
GROUND FLOOR PLAN

- Classroom
- Team Commons
- Special Education
- Vocation/Tech Classroom
- Administration
- Guidance
- Nurse
- Media Center
- Auditorium
- Music
- Art
- Physical Education
- Cafeteria

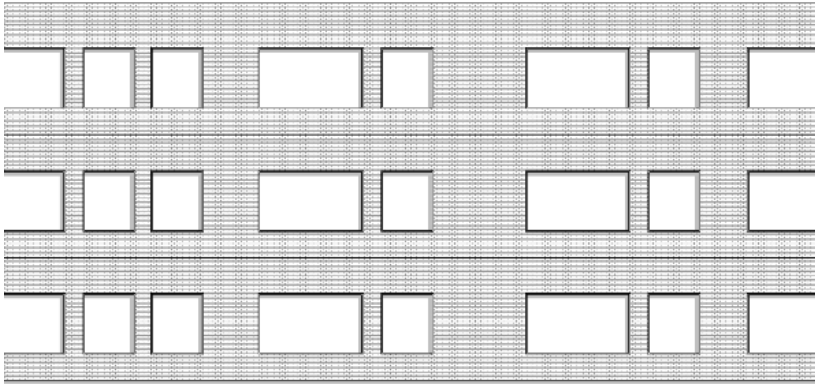
NORTH ELEVATION

Glazing Area/Classroom: 128 SF

Wall Area/Classroom: 350

WWR: 36.6 %

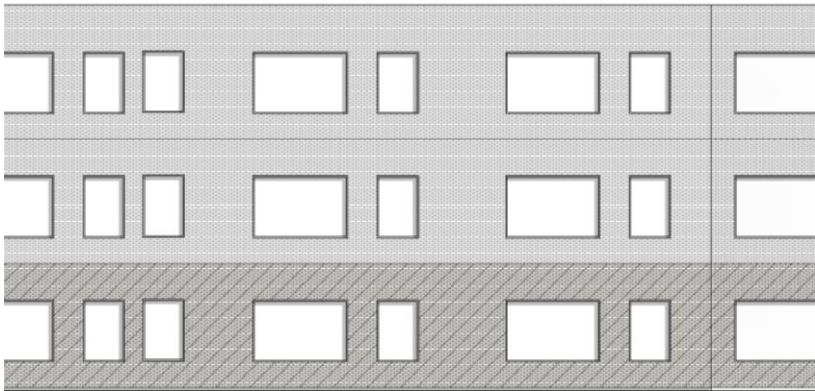
SOUTH ELEVATION

Glazing Area/Classroom: 108 SF

Wall Area/Classroom: 350

WWR: 30.8 %

OVERALL WWR: 25%

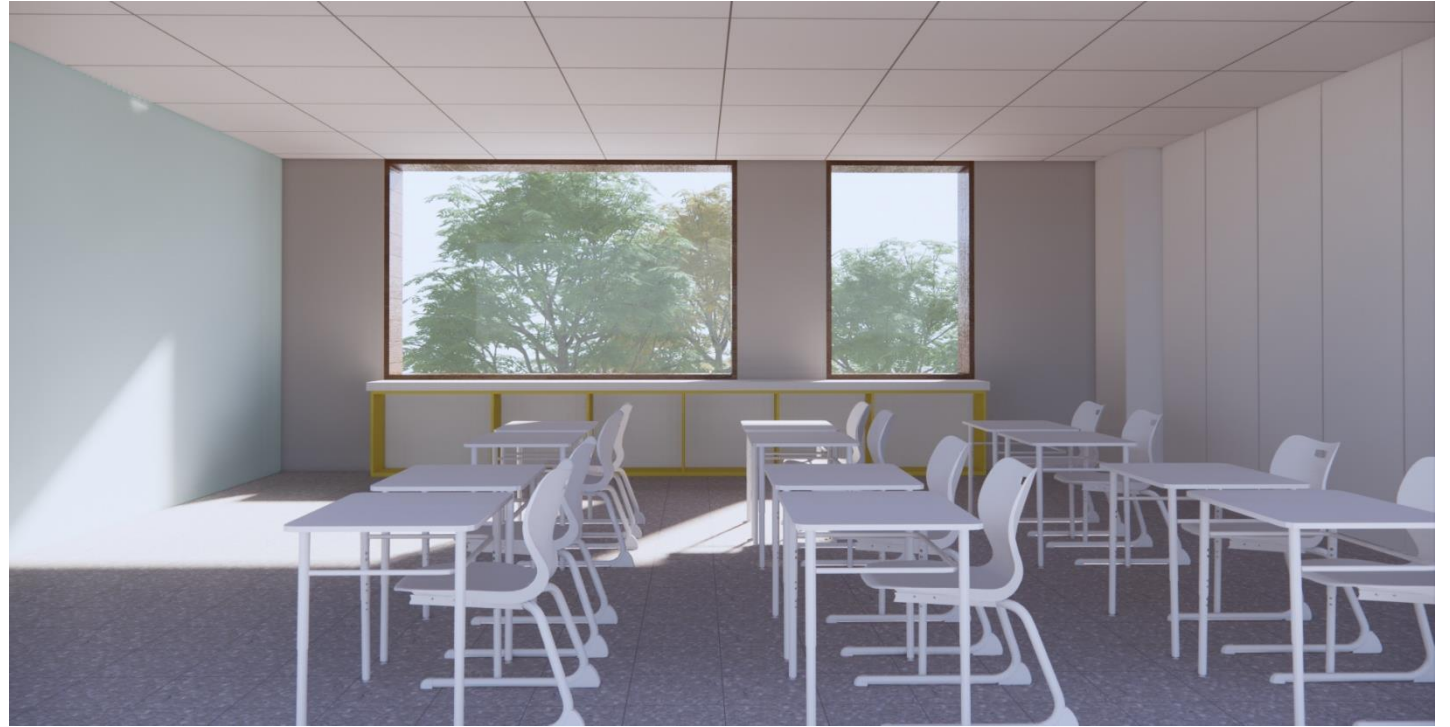
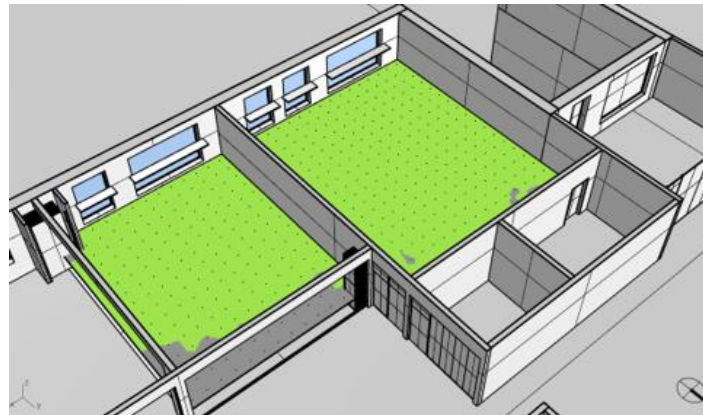
CLASSROOM OPTION 1

Design Option 1 - South Classrooms: 88.1% SDA

Scenario 3 – Ext. Sunshades 24" deep and interior light shelf 18" deep

Design Option 1				Design Option 3				Comments
	sDA (40%, 55% Threshold)		ASE (≤ 10%)		sDA (40%, 55% Threshold)		ASE (≤ 10%)		
	North	South	North	South	North	South	North	South	
Scenario 1 no sunshade/no light shelf	50.0	95.3	0	13.7	33.8	67.9	0	5.7	
Scenario 2 24" Sunshade (S)/18" light shelf (N)	49.0	93.8	0	10.6	40.0	66.1	0	5.3	
Scenario 3 24" Sunshade (S)/18" light shelf (N/S)	49.0 (same as Scen 2)	91.9	0	9.9	40.0 (same as Scen 2)	36.7	0	4.2

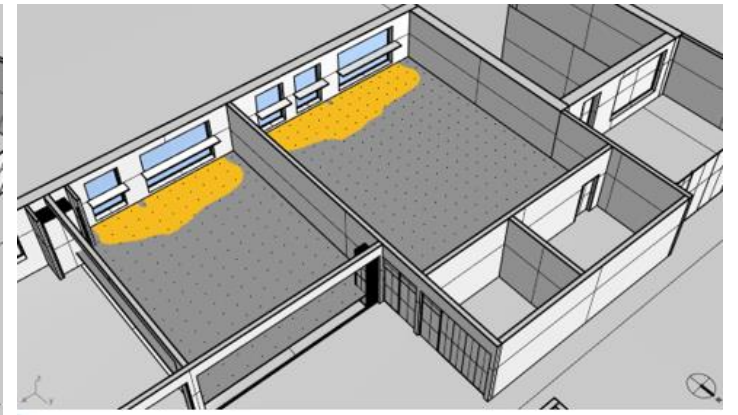
Design Option 1 - South Classrooms: 13.9% ASE

Metric	LEEDv4	
ASE <small>(1000,250)</small>	<= 10%	required
sDA <small>(300/50)</small>	40%	1 pt
	55%	2 pt
	75%	Exemplary

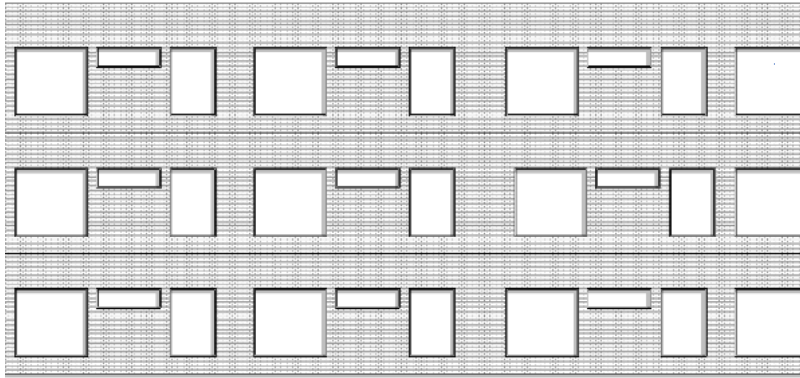
NORTH ELEVATION

Glazing Area/Classroom: 128 SF
 Wall Area/Classroom: 350
 WWR: 36.6 %

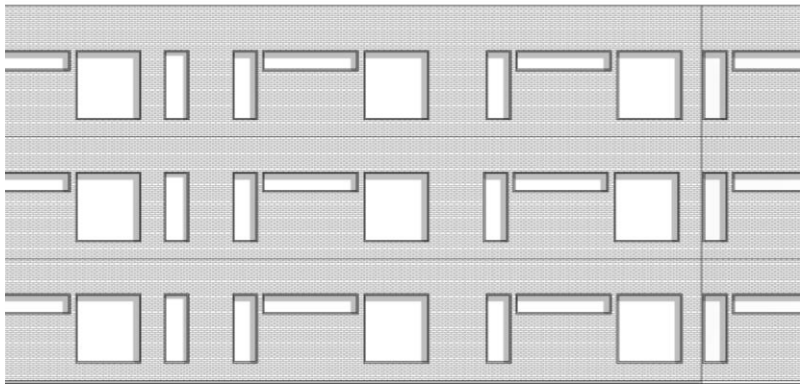
SOUTH ELEVATION

Glazing Area/Classroom: 108 SF
 Wall Area/Classroom: 350
 WWR: 30.8 %

OVERALL WWR: 25%

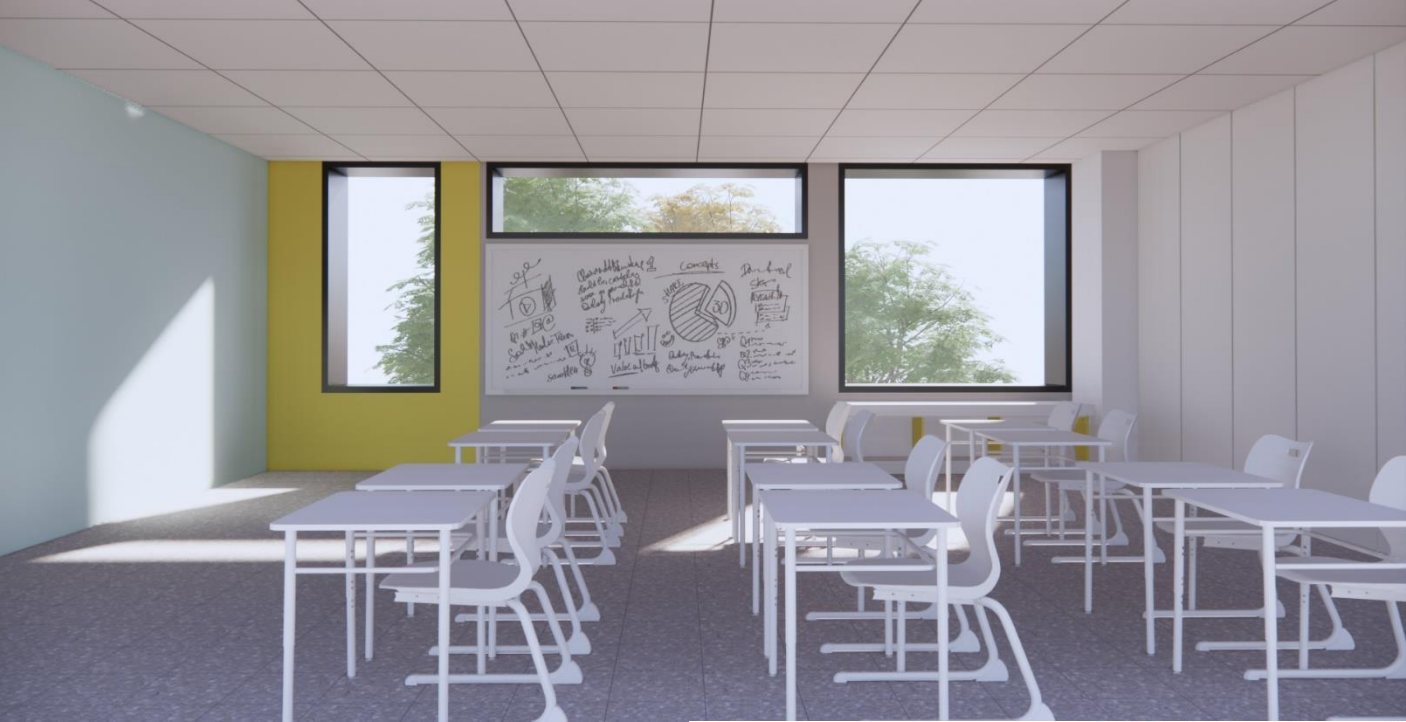
CLASSROOM OPTION 3

Design Option 2 - South Classrooms: 58.1% SDA
 Scenario 3 – Ext. Sunshades 24" deep and interior light shelf 18" deep

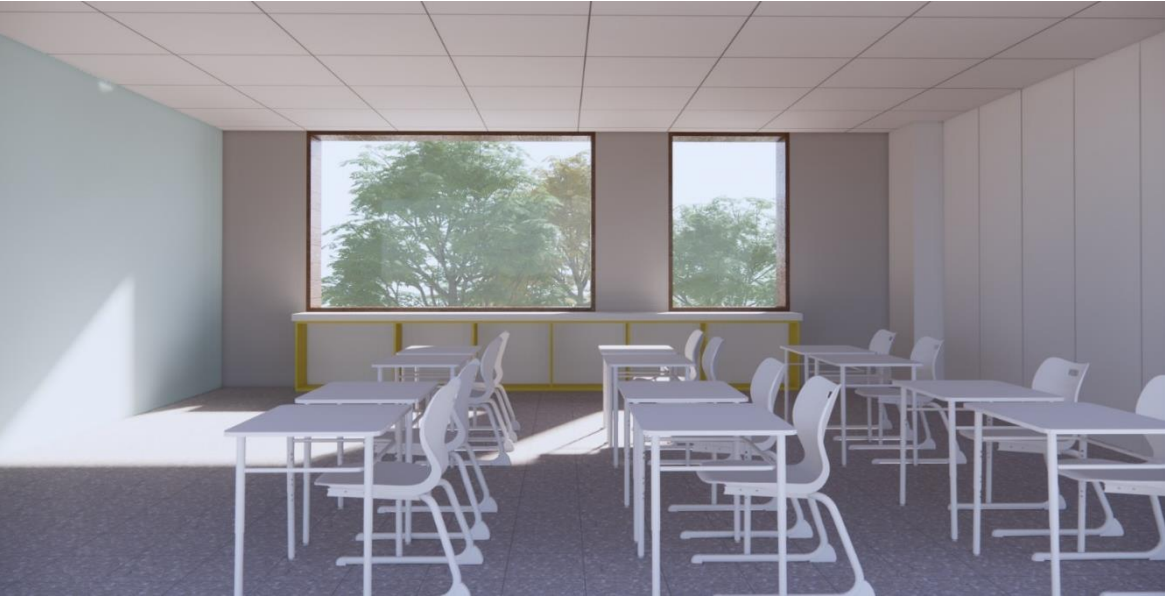
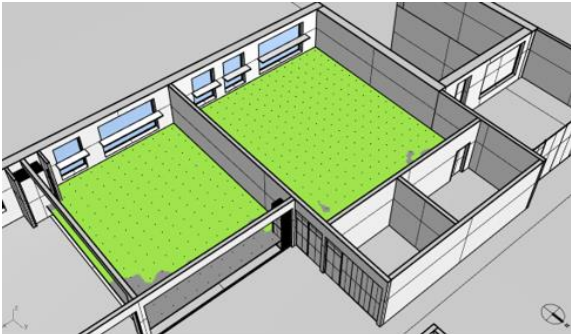
OPTION 1

Design Option 1 - South Classrooms: 88.1% SDA

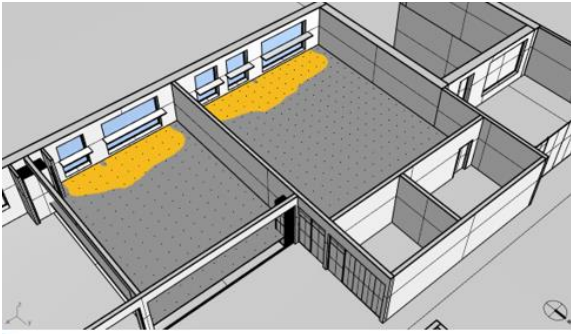
Design Option 1 - South Classrooms: 13.9% ASE

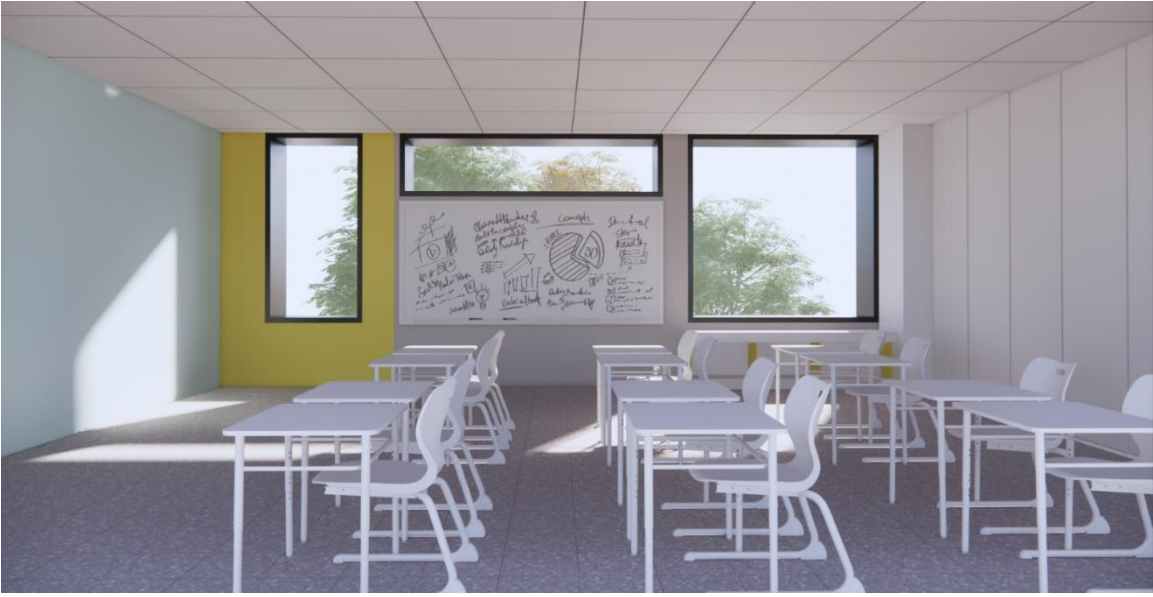
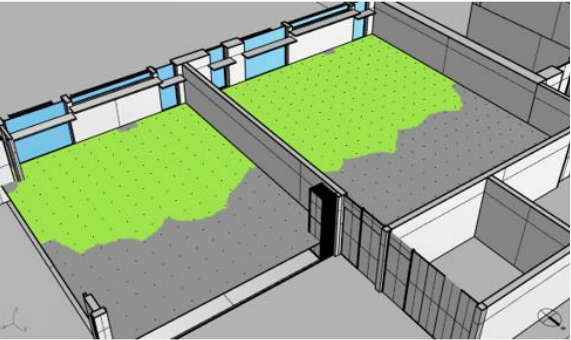
OPTION 3

Design Option 2 - South Classrooms: 58.1% SDA

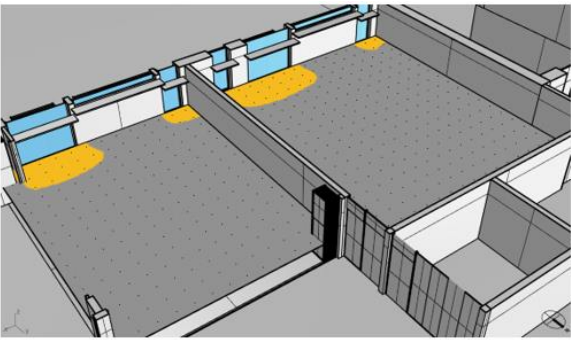
Design Option 2 - South Classrooms: 7.5% ASE

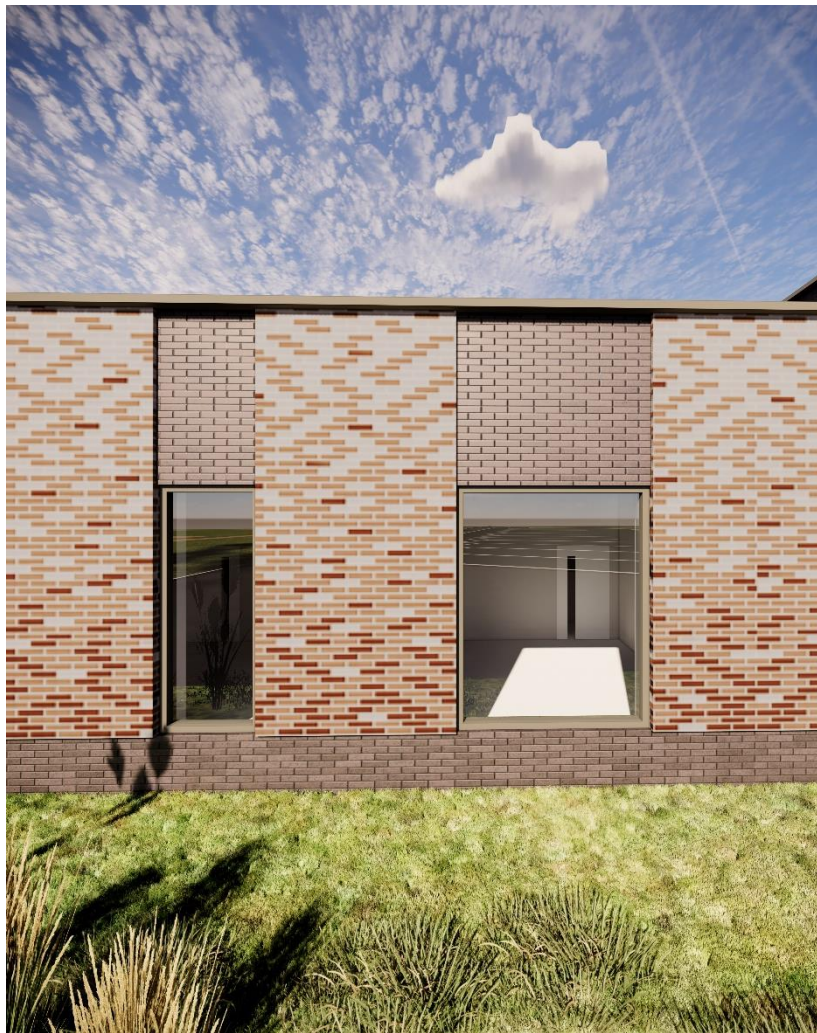
OPTION 1 – MIST GRADIENT BRICK

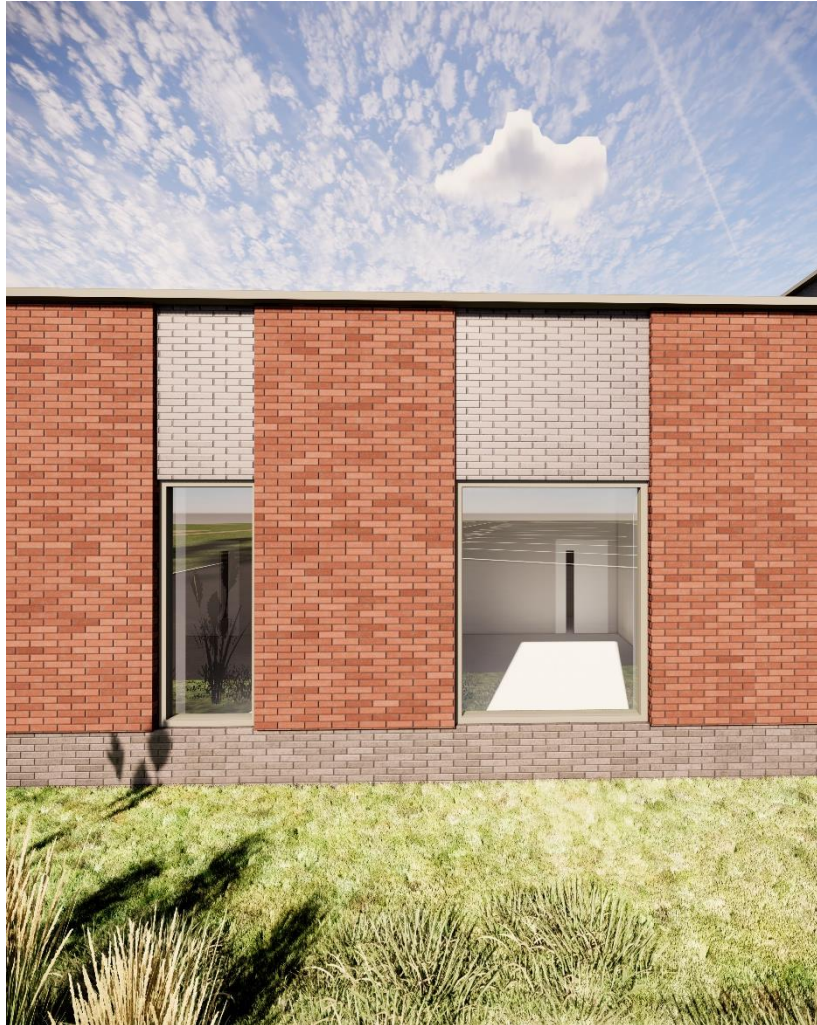
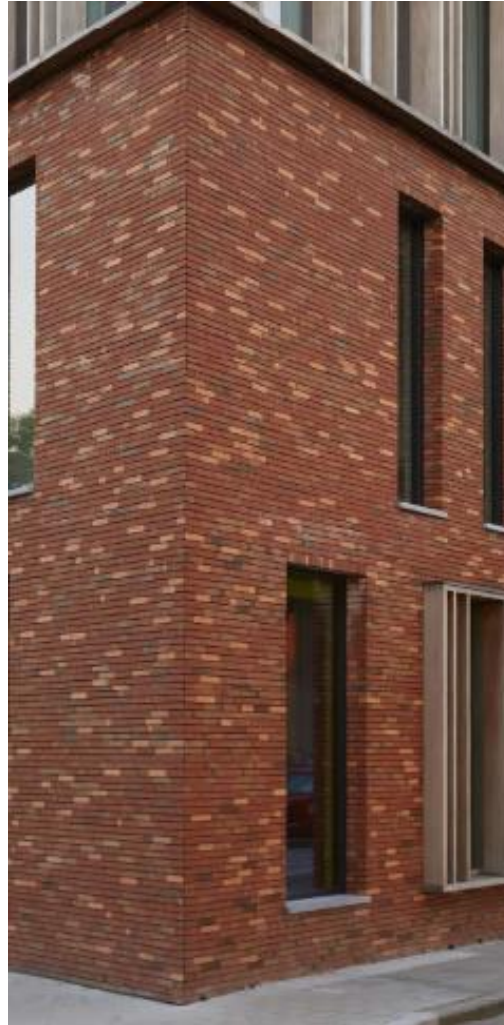
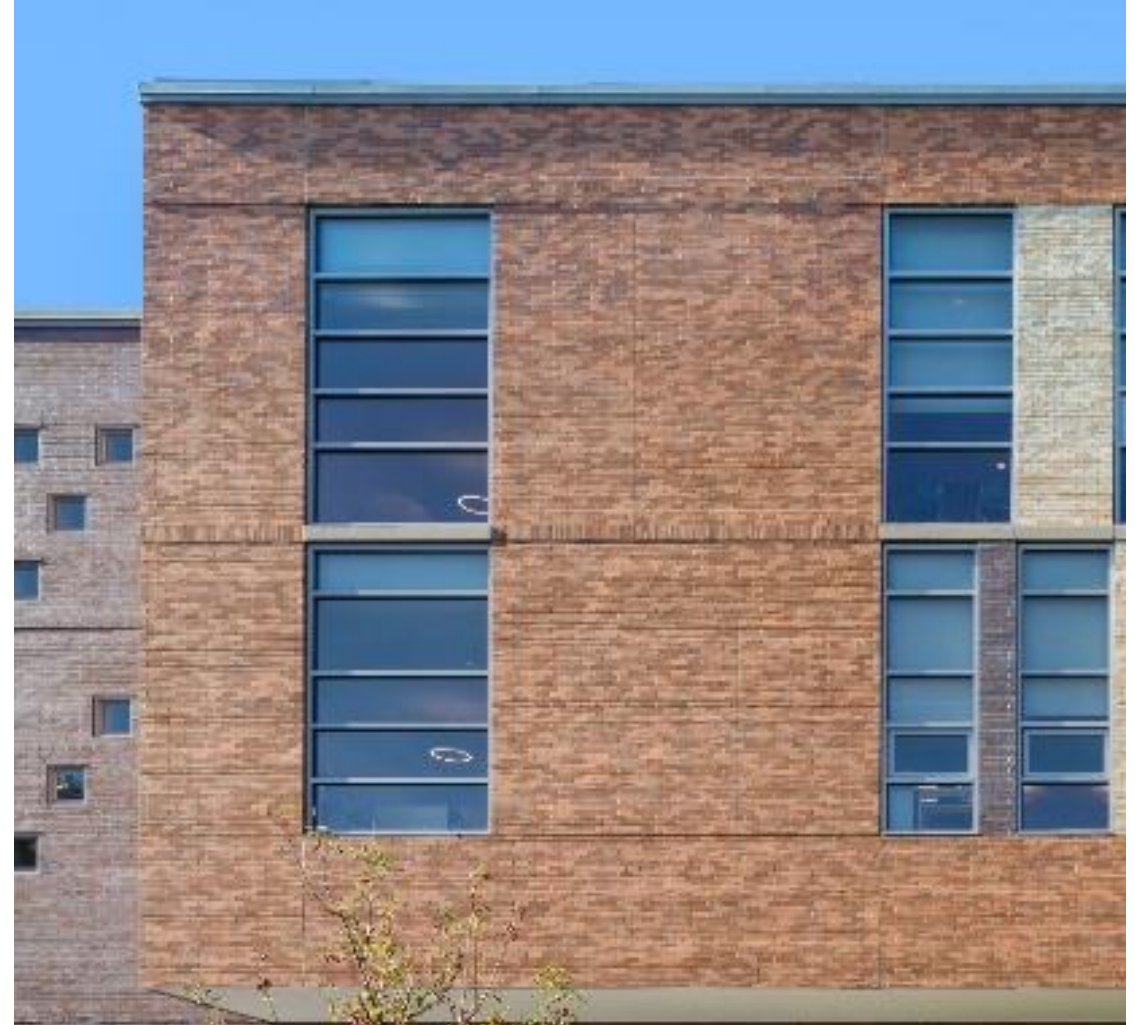
OPTION 2 – SOLID SINGLE COLOR BRICK BLEND

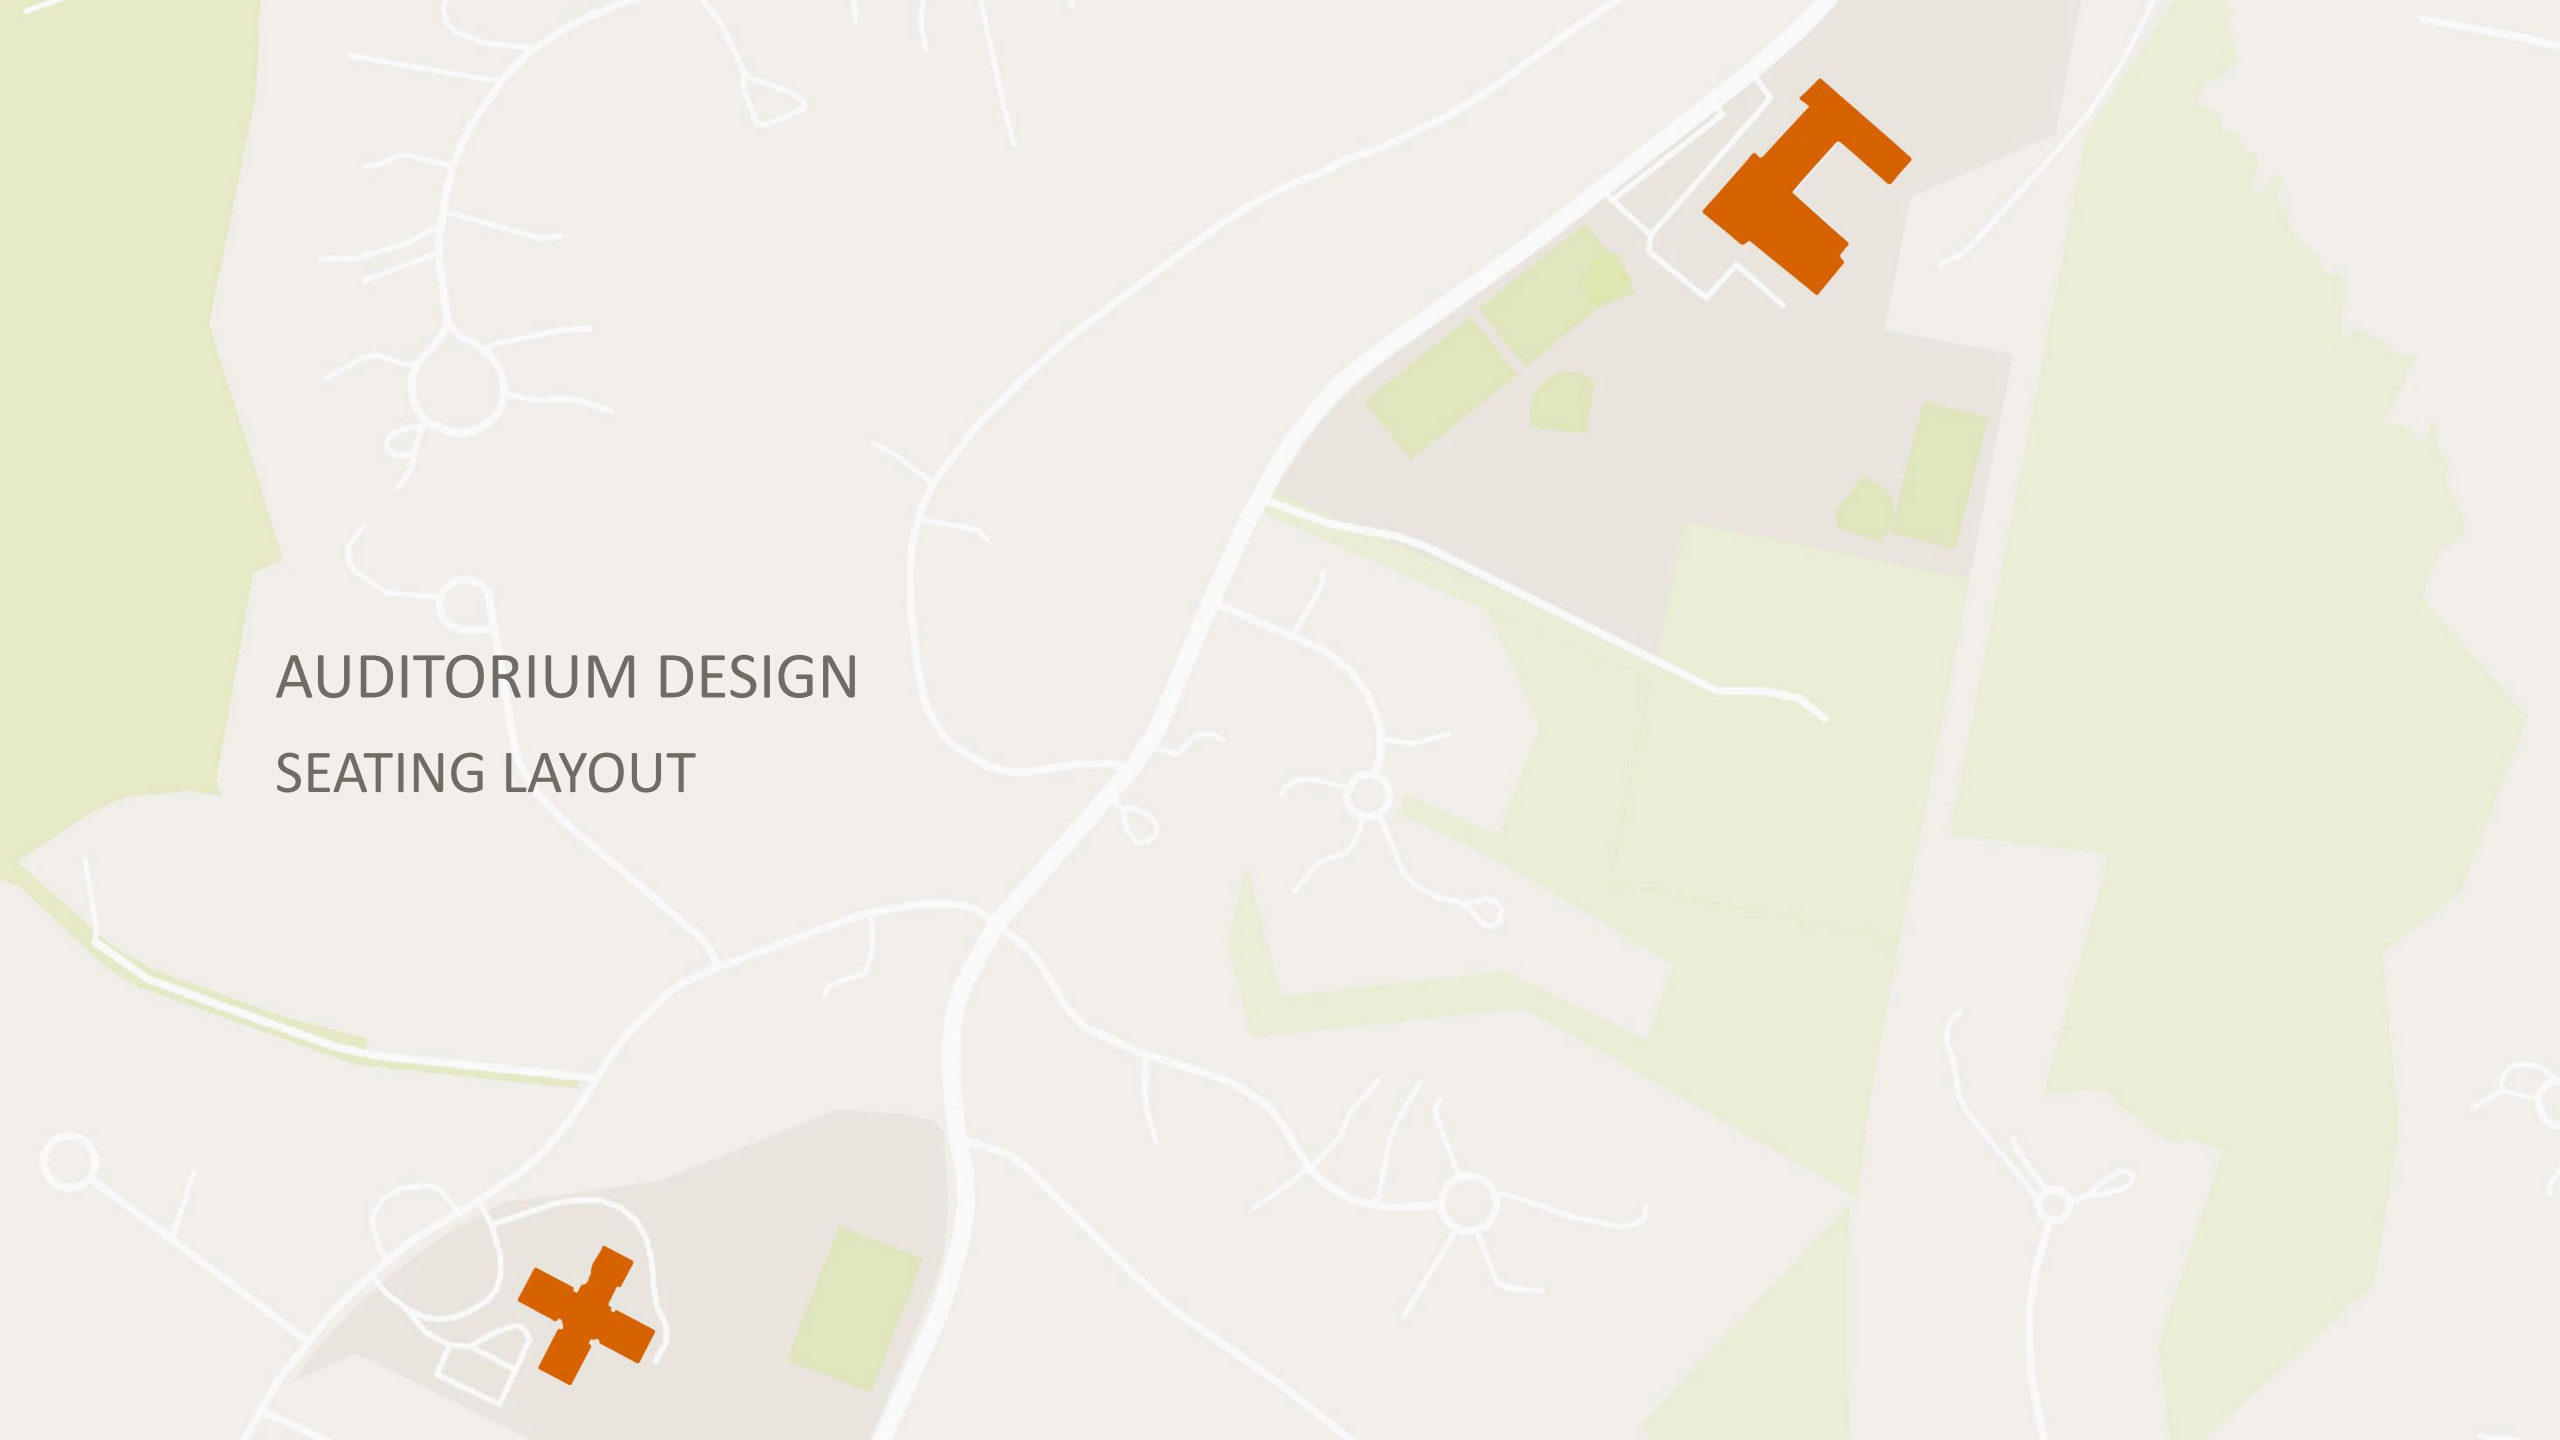
AUDITORIUM DESIGN
SEATING LAYOUT

OPTION 1 – HYBRID BLACKBOX FLIPPED

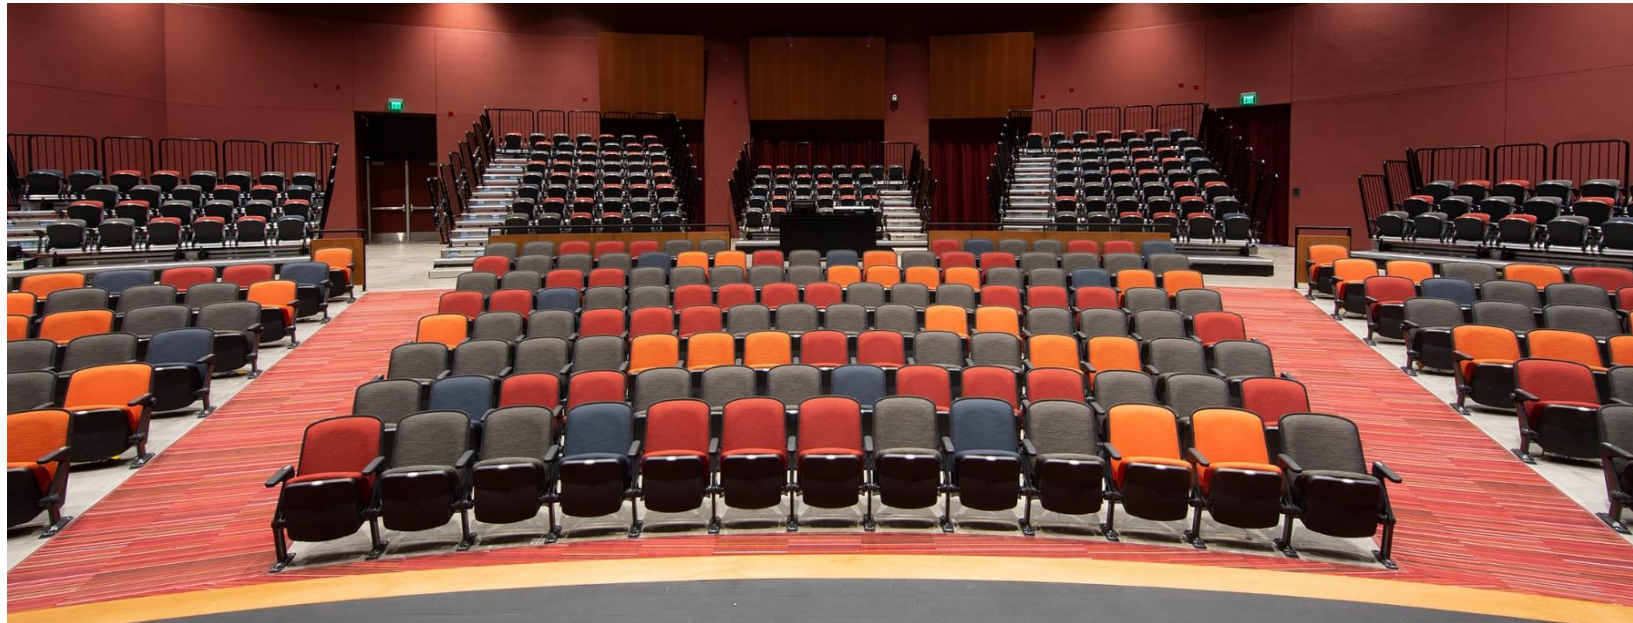
- Acoustics, finishes, and mechanical system to match conventional auditorium
- Multiple activities can operate simultaneously – with potential for separate mechanical control
- Front (fixed seating) can accommodate one full grade

- Increased distance from furthest seat to stage
- Operable partition and seats will require maintenance
- Perception of unconventional

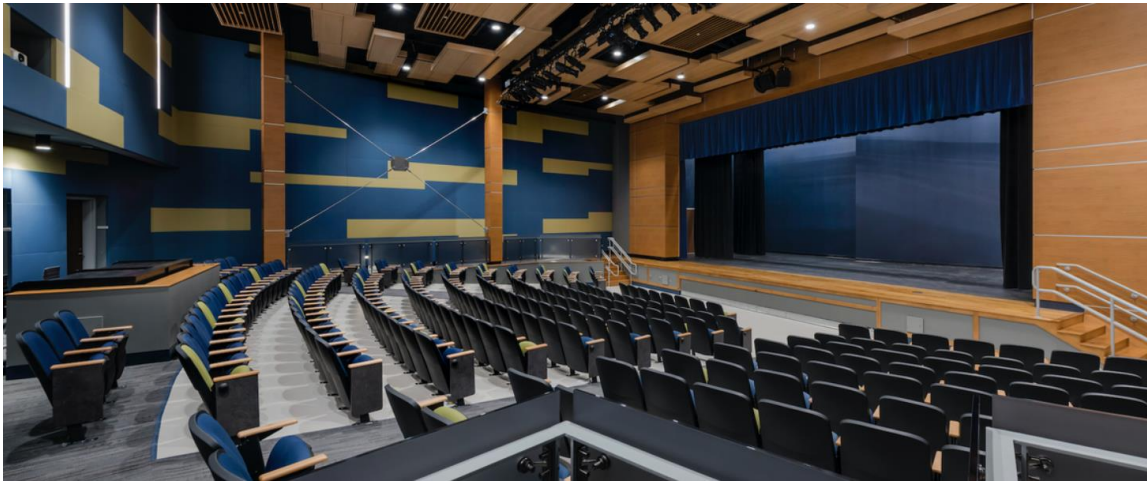
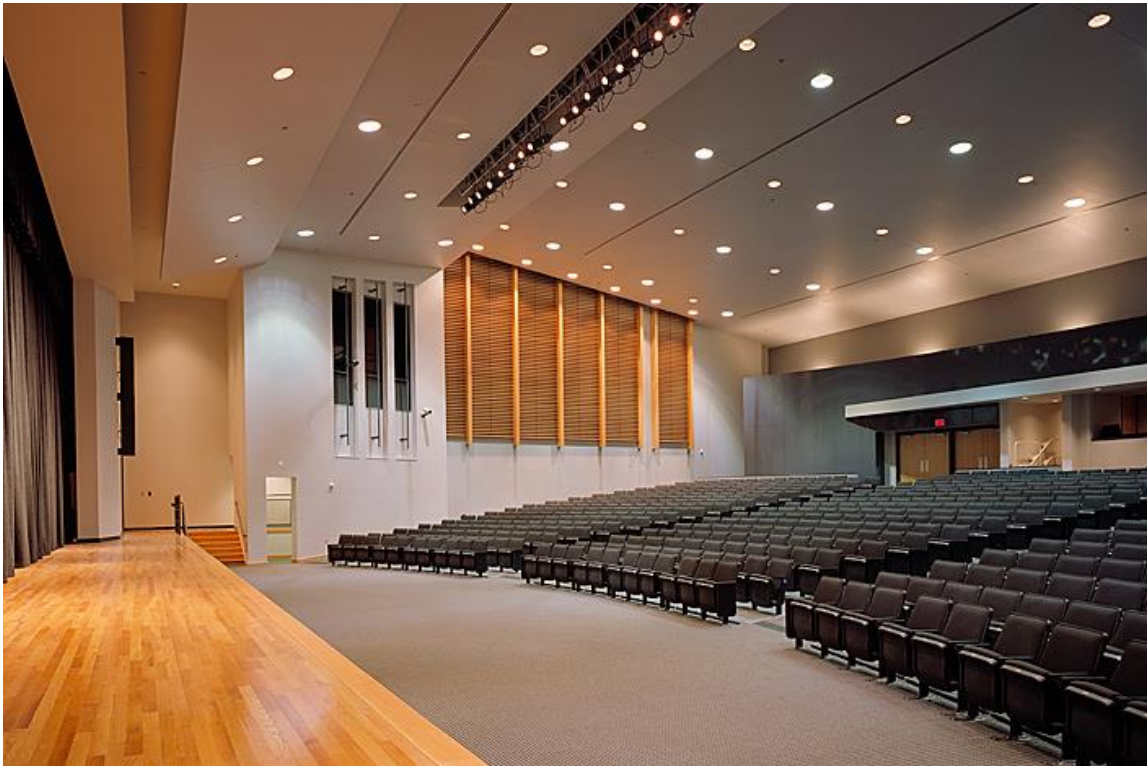
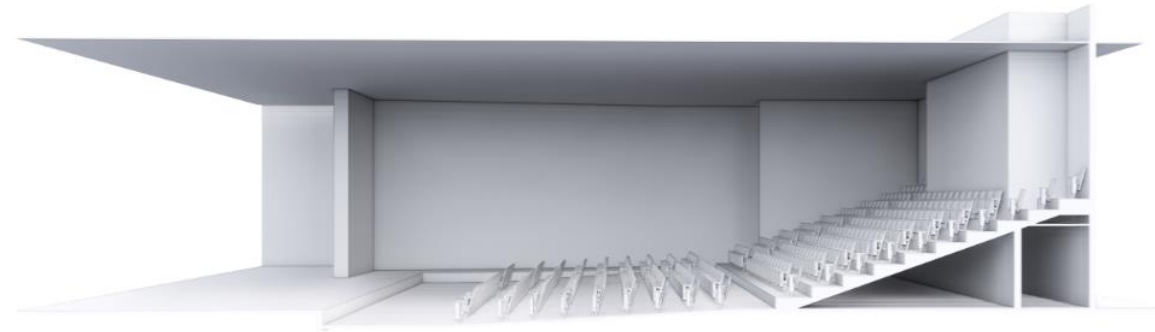
- Floor Plan rotation allows for wider seating house
- Shorter sightlines from back row
- Shorter distance walking from back row to stage
- Uniform treatment of space

- Limits use of space only as a conventional auditorium

OPTION 2 – SLOPED FLOOR WIDE FAN

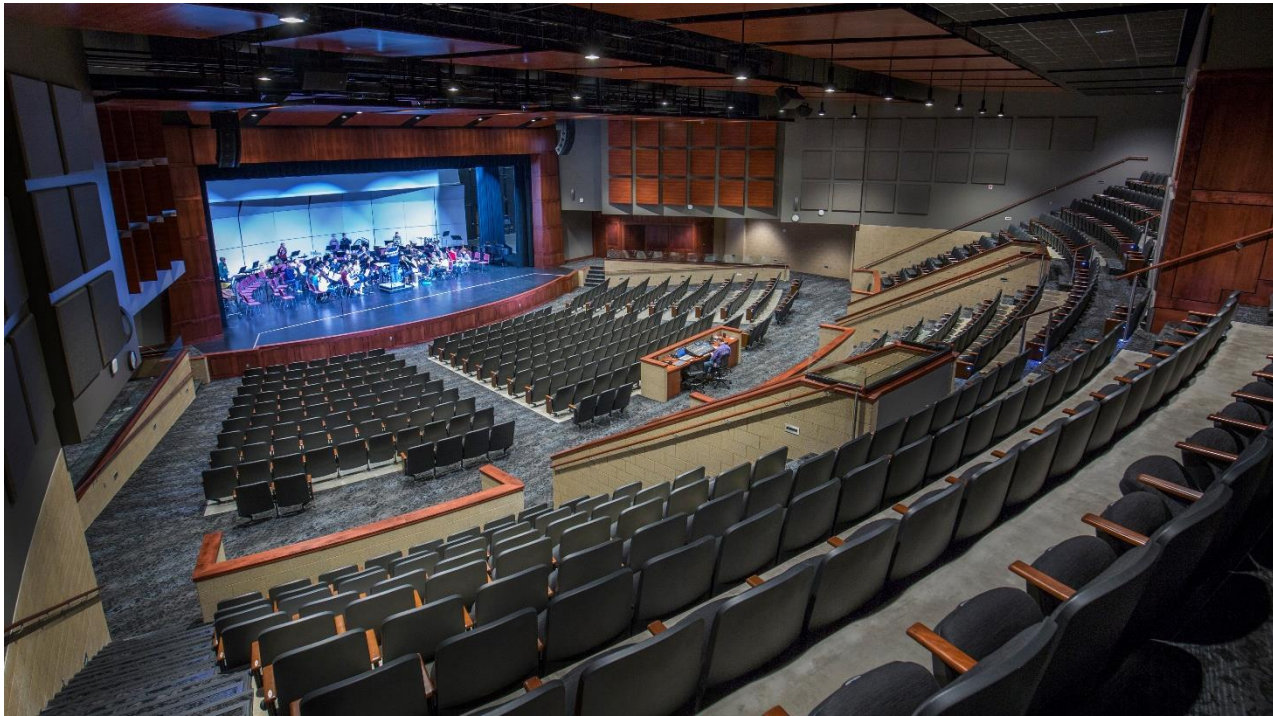
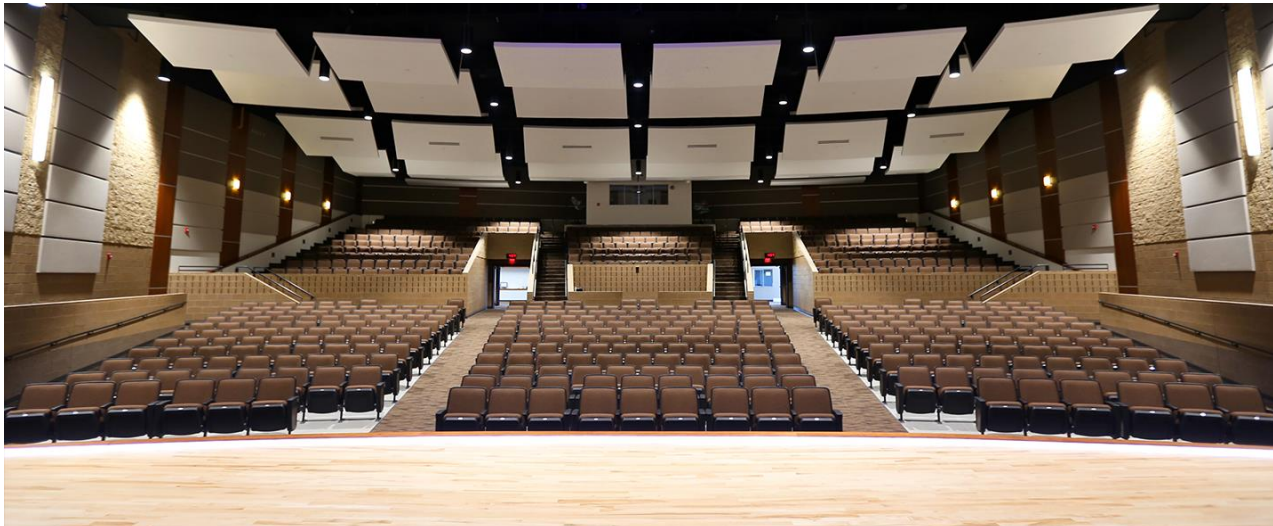
- Common layout found in many schools
- Uniform treatment of space
- Potential to use space below stepped seating
- Stepped seating in rear shortens sightlines to stage from back row

- Limits use of space only as a conventional auditorium
- Increased distance from furthest seat to stage
- Will require further study of distribution of wheelchair accessible seats

OPTION 3 – TIERED SIDE ENTRANCE FLIPPED

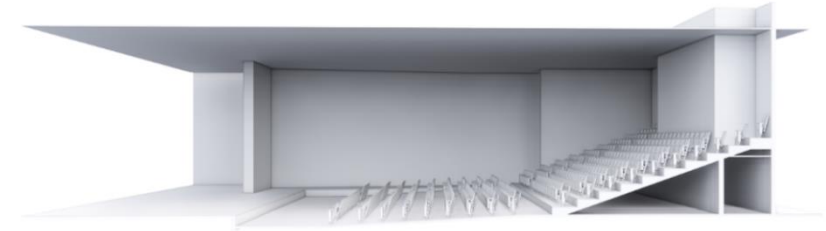
OPTION 3: SLOPED & STEPPED SEATING

Furthest Seat: 82' Feet from Proscenium
 Seating House: 74'x84'
 Stage Width: 38'
